PHASE I ENVIRONMENTAL SITE ASSESSMENT

276 DUKE STREET DRYDEN, ONTARIO

FEBRUARY 2021

FILE NO.: 21-363-01

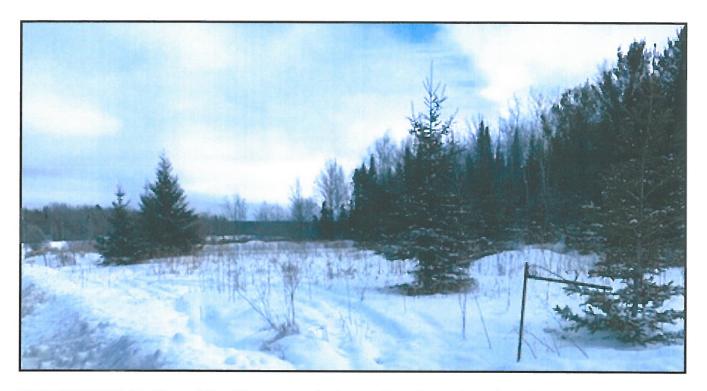
PHOTOGRAPH #1: View of the Site as seen facing east-southeast from the northwest corner of the Site.

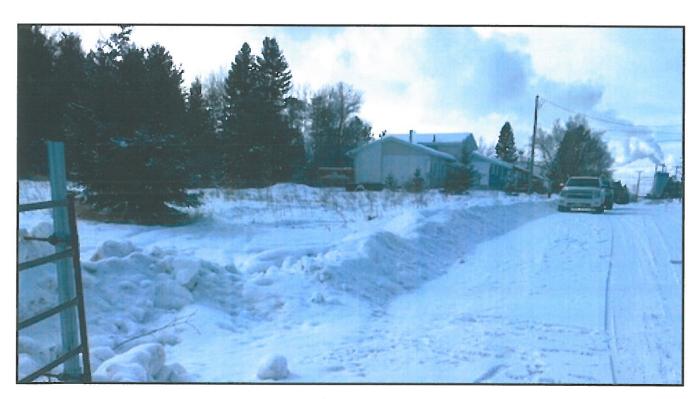
PHOTOGRAPH #2: View of the Site as seen facing west-southwest from the northeast corner of the Site.

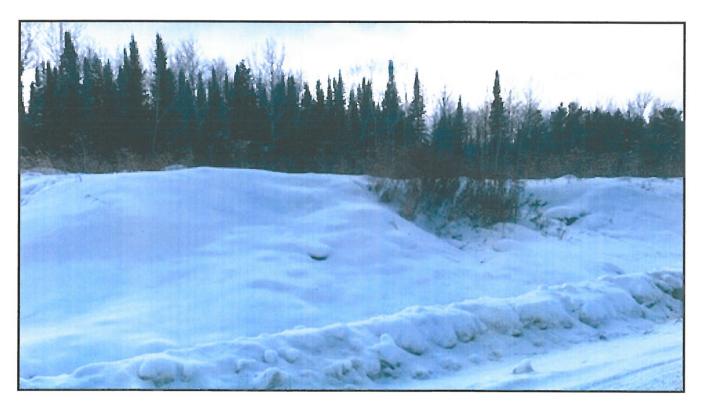
PHOTOGRAPH #3: View of the Site from Duke Street as seen facing south-southwest.

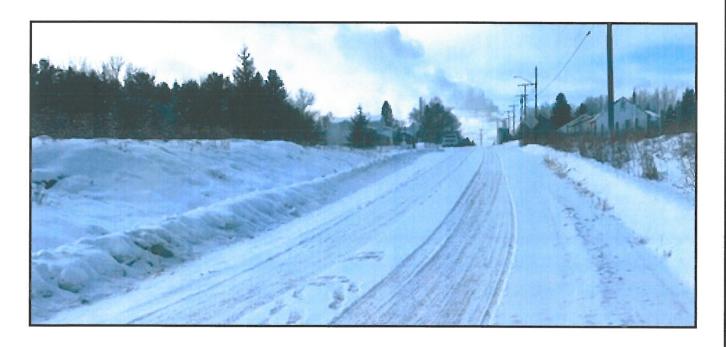
PHOTOGRAPH #10: View of Duke Street facing west (the Site is visible along the left side of the photograph).

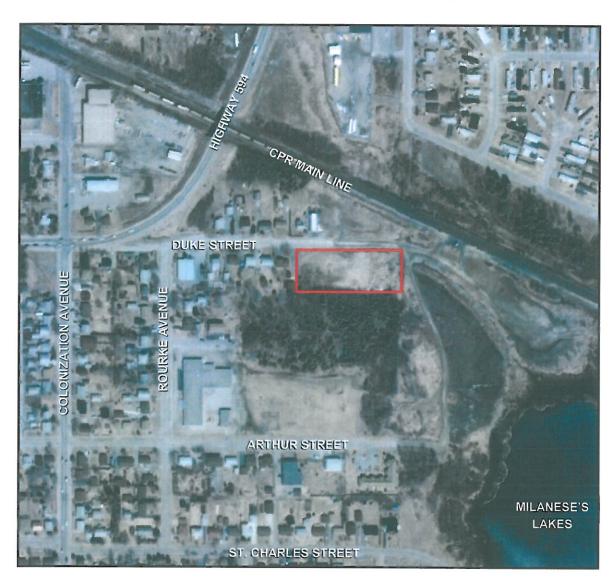
Photo date: April 27, 2002 Image from Google Earth™ © 2021 Maxar Technologies

The Site was undeveloped until at least 1969. Between 1969 and 2002, the trees on the Site were cleared. The fill brought to the southeast portion of the Site was visible since 2002.

Approximately 20 to 30 piles of soil have been dumped at the southeast corner of the property. The source of these soil piles is unknown but they have been present since at least 2002 (based on aerial photographs).

ENG-TECH concludes that there were APECs related to current and/or historical on-site and off-site land use and recommends that a Phase II ESA be conducted to assess these areas.
